**BUILDING AND PEST**  
**INSPECTION**  
BRISBANE.COM.AU

**Building Inspection**  
**SAMPLE REPORT**

## AS 4349.3 Timber Pest Inspection

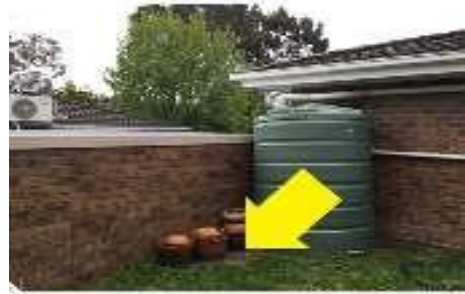
There was significant soil build up against garage walling. Dampness issues could be at play. Drainage and/or Geo-Technical assessment recommended.

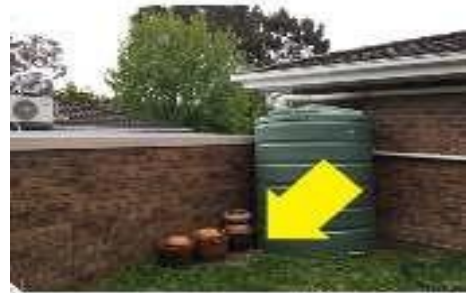
#### Soils

Significant soil build up evident. Drainage specialist and/or geo-technical engineering assessment recommended prior to purchase.

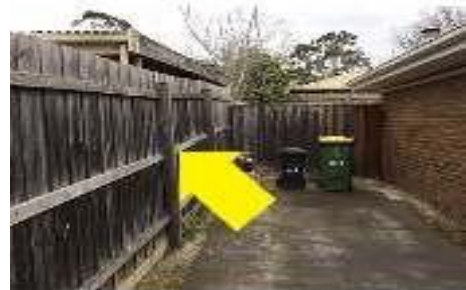
##### The Fencing Leans

The fencing leans. Leaning fences can collapse. Fencing assessment recommended.

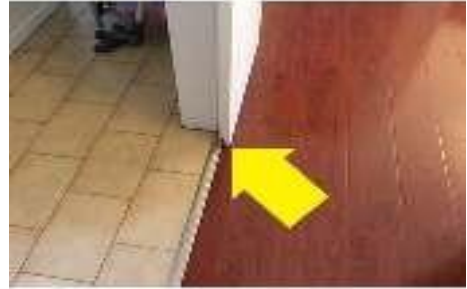
Areas of the door were damaged. Carpentry or builders assessment recommended.

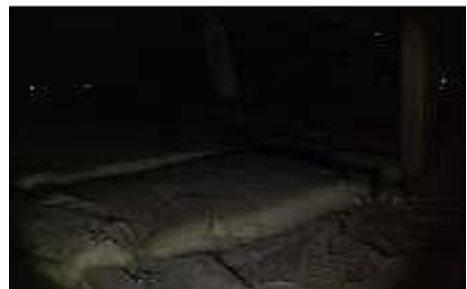
##### **Ceiling Joists Covered**

A significant amount of the ceiling joists were hidden due to insulation, stored items or other coverings. Where the ceiling joists are not visible the inspector cannot gauge the stability of the joists and could be vulnerable to a collapse. The roof void was only inspected with a torchlight viewing from the manhole. Access should be gained.

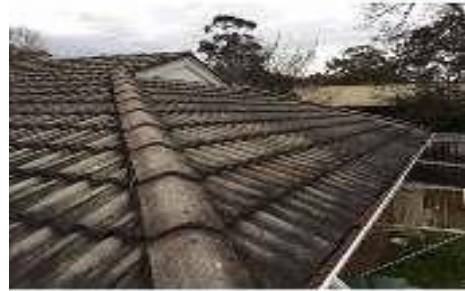
##### **The Tiles have Aged**

The tiles have aged where surface gloss has deteriorated. We recommend that you have the roof surface spray cleaned, re-sealed, re-pointed and re-painted. Roofing assessment recommended.

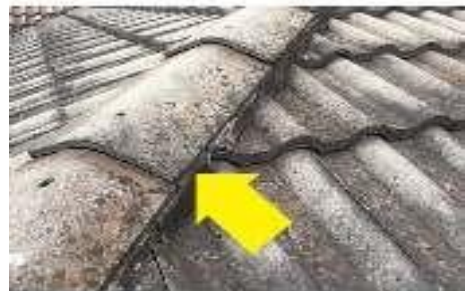
##### **Loose or Missing Ridge Mortar**

Loose or missing ridge mortar evident. Roofing assessment recommended.

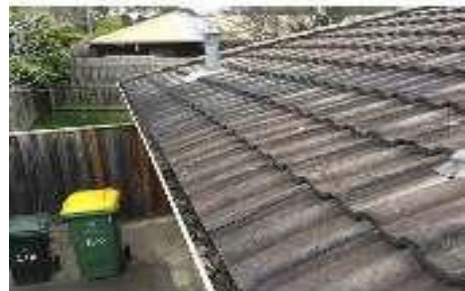
#### Guttering

Gutters are holding debris. Clearing or Plumbing assessment recommended.

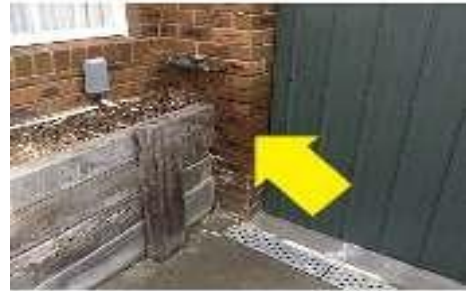
#### **Mortar Erosion Evident**

Areas evident mortar erosion or dusting. Damp issues may be at play. Dampness and bricklaying assessment recommended.

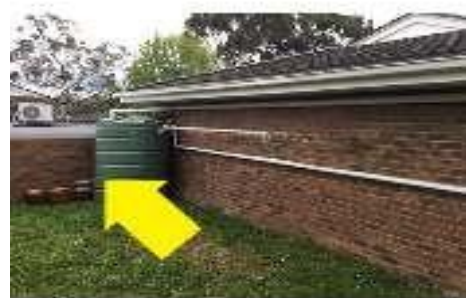
The exterior brickwork evidences damp areas. There may be poor drainage or rising damp issues at play. I highly recommend that you have a dampness assessment as well as a drainage assessment carried out prior to purchase.

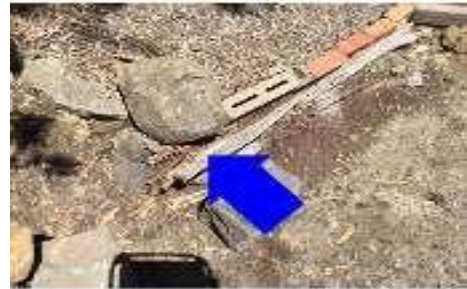
Timber Retainers

Was evidence of termite workings found?
