# Building Inspection SAMPLE REPORT

## **AS 4349.3 Timber Pest Inspection**

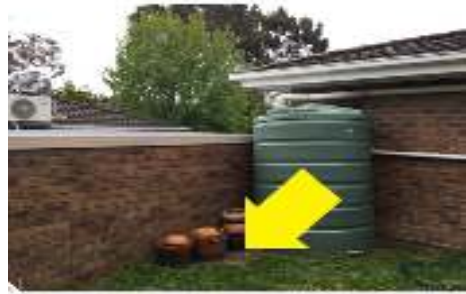
There was significant soil build up against garage walling. Dampness issues could be at play. Drainage and/or Geo-Technical assessment recommended.

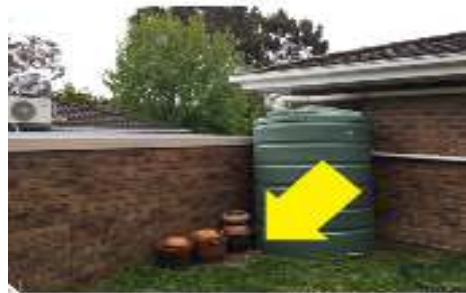
#### Soils

Significant soil build up evident. Drainage specialist and/or geo-technical engineering assessment recommended prior to purchase.

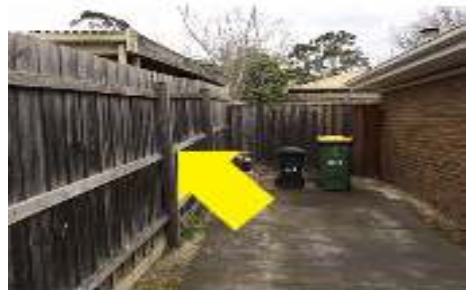
##### The Fencing Leans

The fencing leans. Leaning fences can collapse. Fencing assessment recommended.

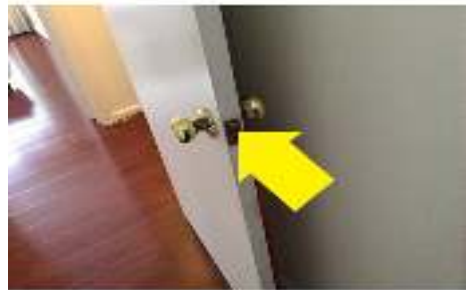
Missing Screws Evident. Repairs recommended.

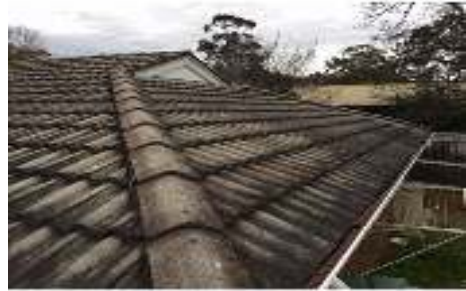
##### **The Tiles have Aged**

The tiles have aged where surface gloss has deteriorated. We recommend that you have the roof surface spray cleaned, re-sealed, re-pointed and re-painted. Roofing assessment recommended.

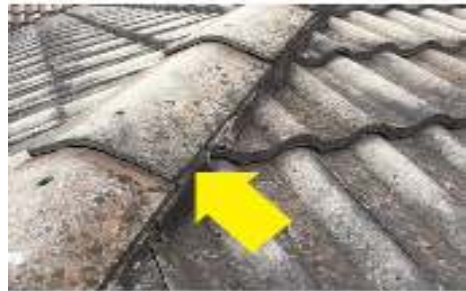
##### **Loose or Missing Ridge Mortar**

Loose or missing ridge mortar evident. Roofing assessment recommended.

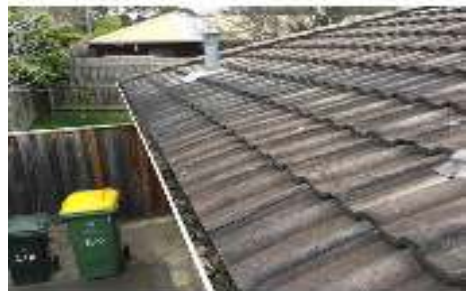
#### Guttering

Gutters are holding debris. Clearing or Plumbing assessment recommended.

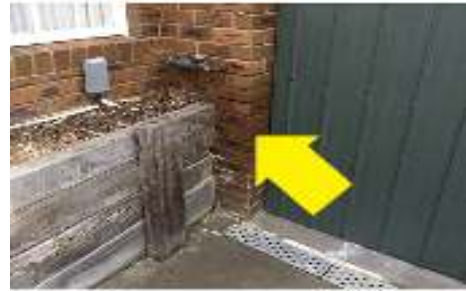
#### **Mortar Erosion Evident**

Areas evident mortar erosion or dusting. Damp issues may be at play. Dampness and bricklaying assessment recommended.

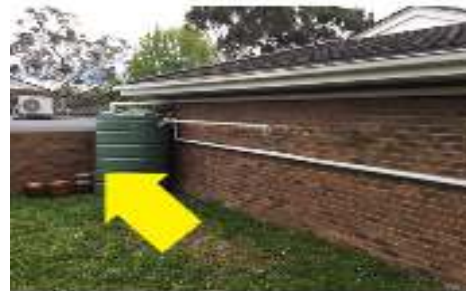
The exterior brickwork evidences damp areas. There may be poor drainage or rising damp issues at play. I highly recommend that you have a dampness assessment as well as a drainage assessment carried out prior to purchase.

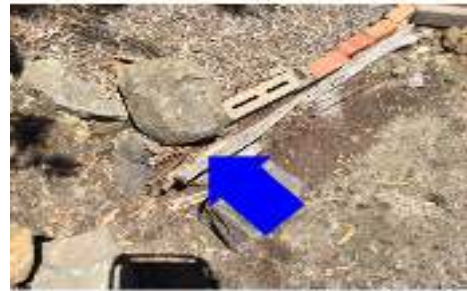
Timber Retainers

Was evidence of termite workings found?

And was found in the following areas...
